# Portage Creek Sediment Remediation Project Kalamazoo, Michigan

## Pre-Sediment Removal Structure Feature Assessment Removal Areas SA3-A, SA3-B and SA3-Access

F&V Project Number: 809930  
August, 2012

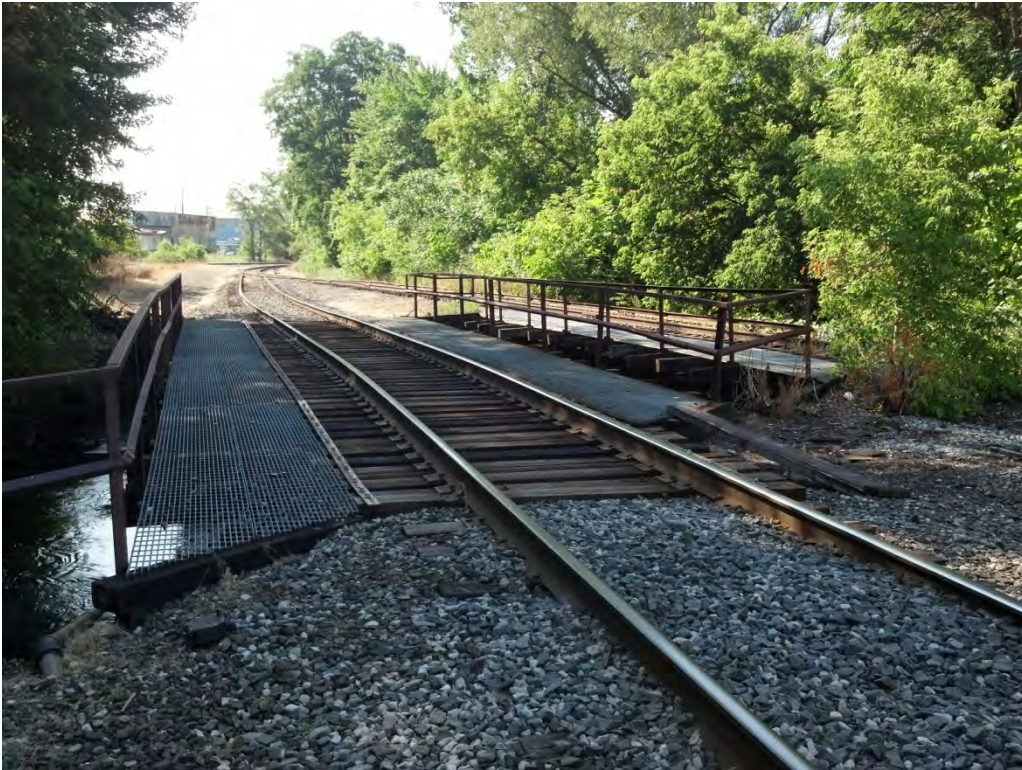
Structure viewed from track level

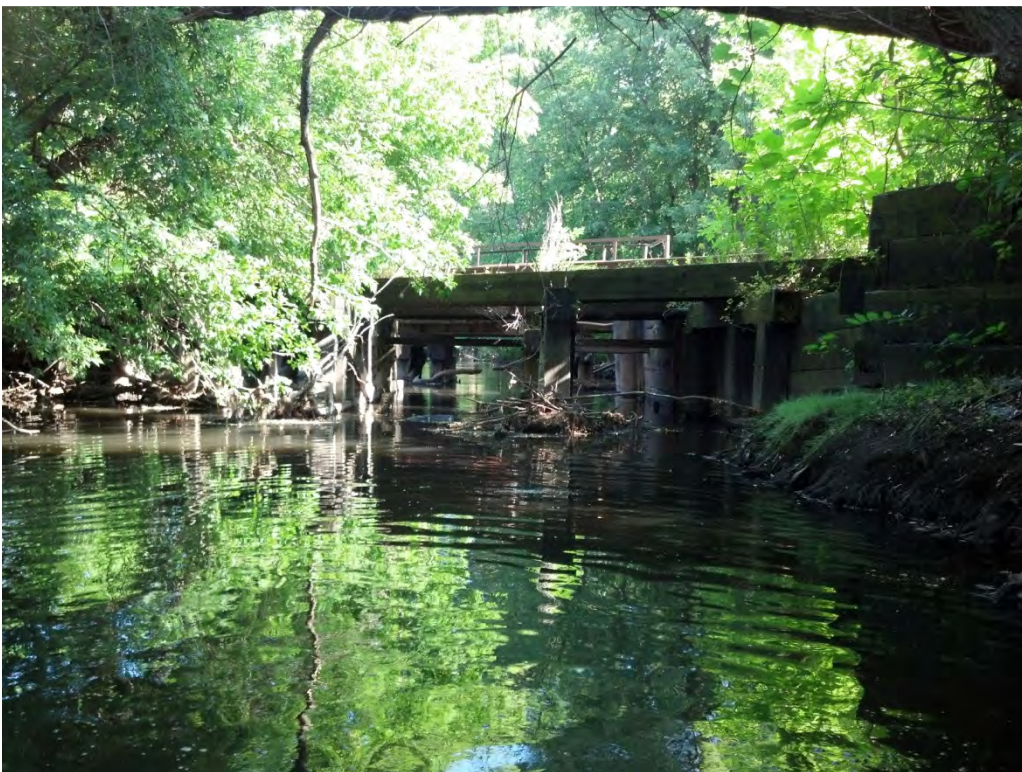
Elevation view of the structure

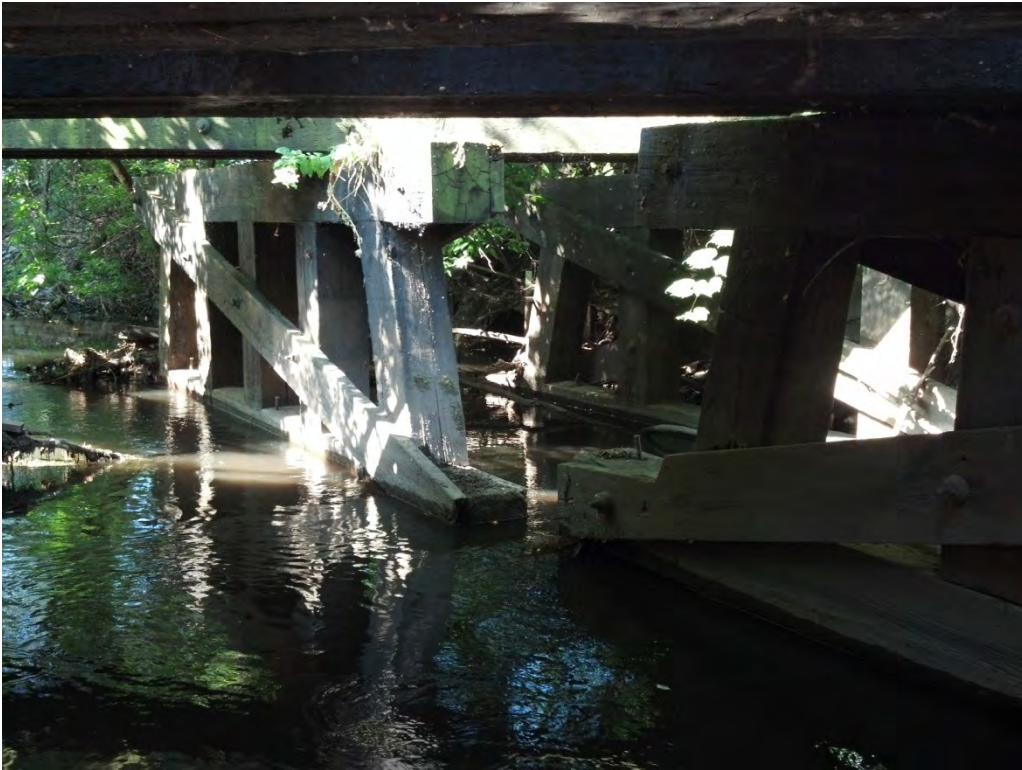
Vegetation growth on timber bent

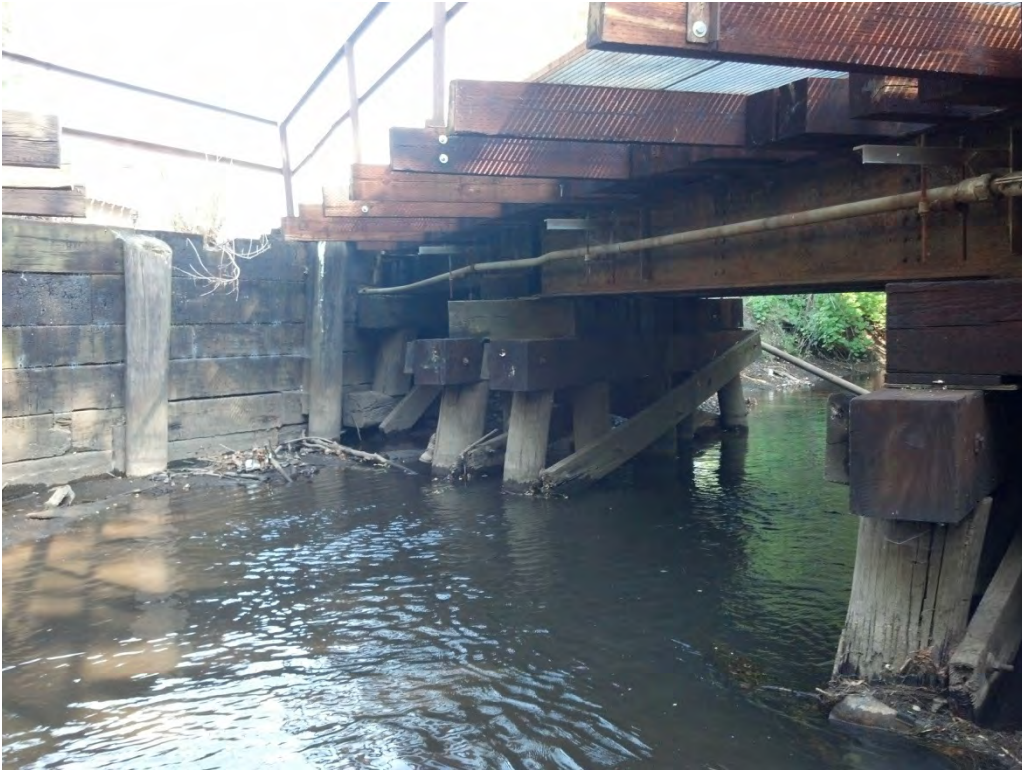
Conduit supported on south side of north structure

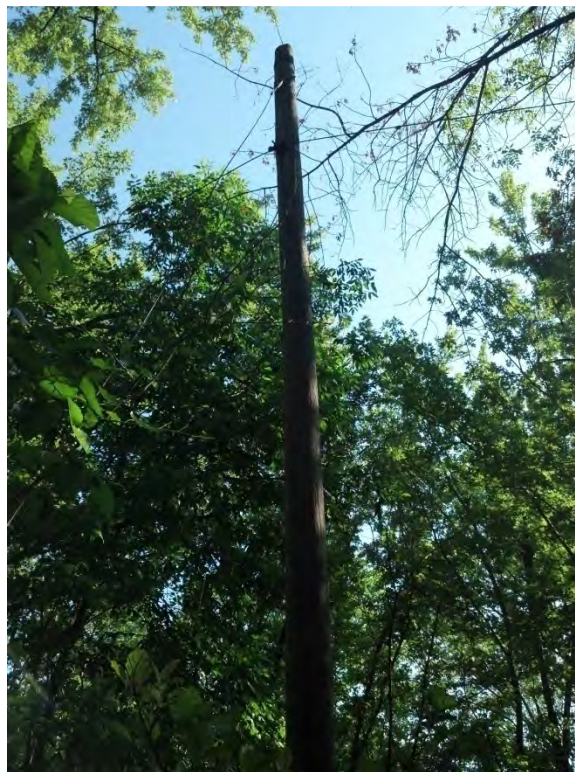
View of the overhead facilities carried by the pole

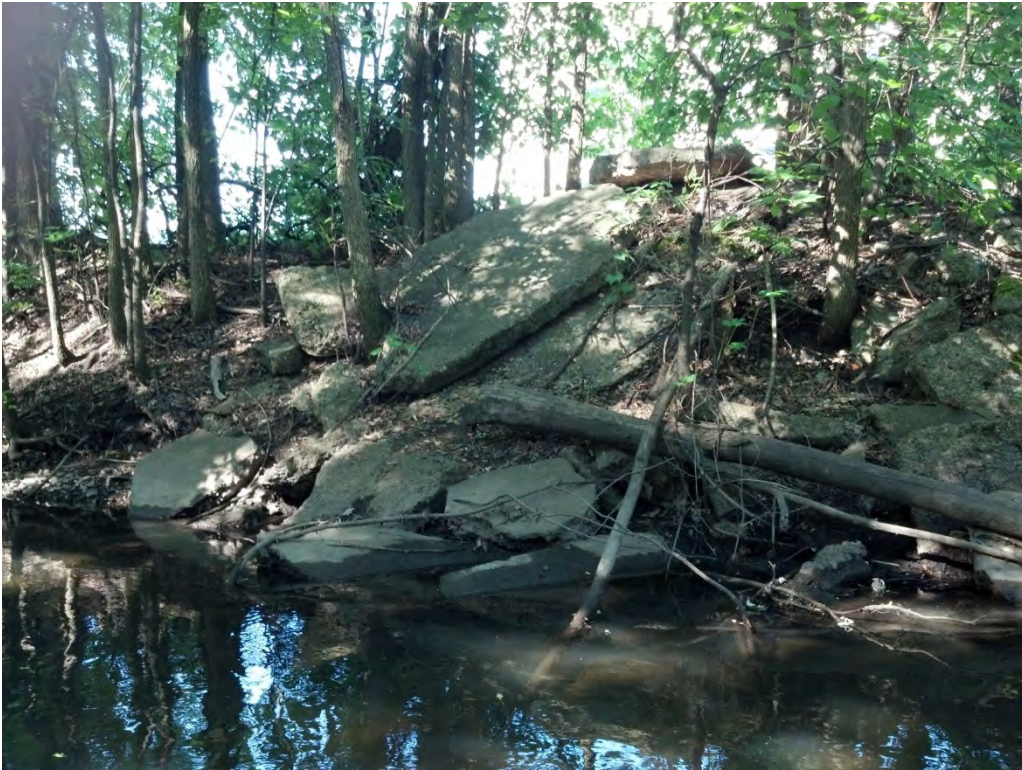
View of the structure from the channel

- The slabs should be removed and replaced as required to facilitate sediment removal.

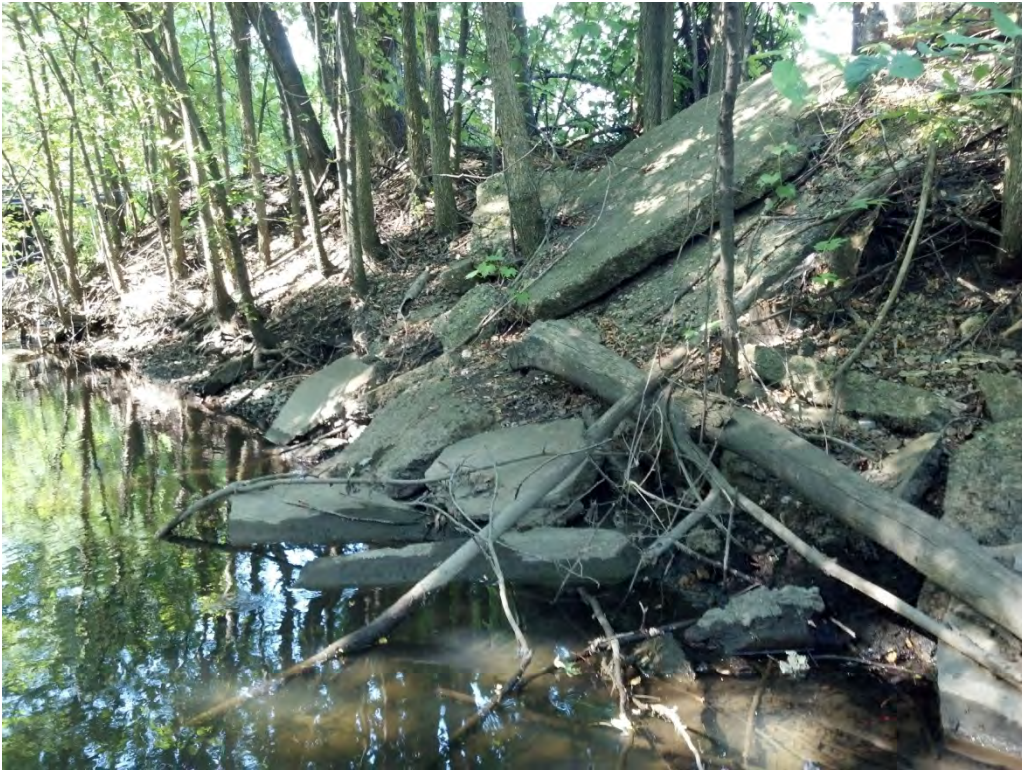
View of the structure from the north channel

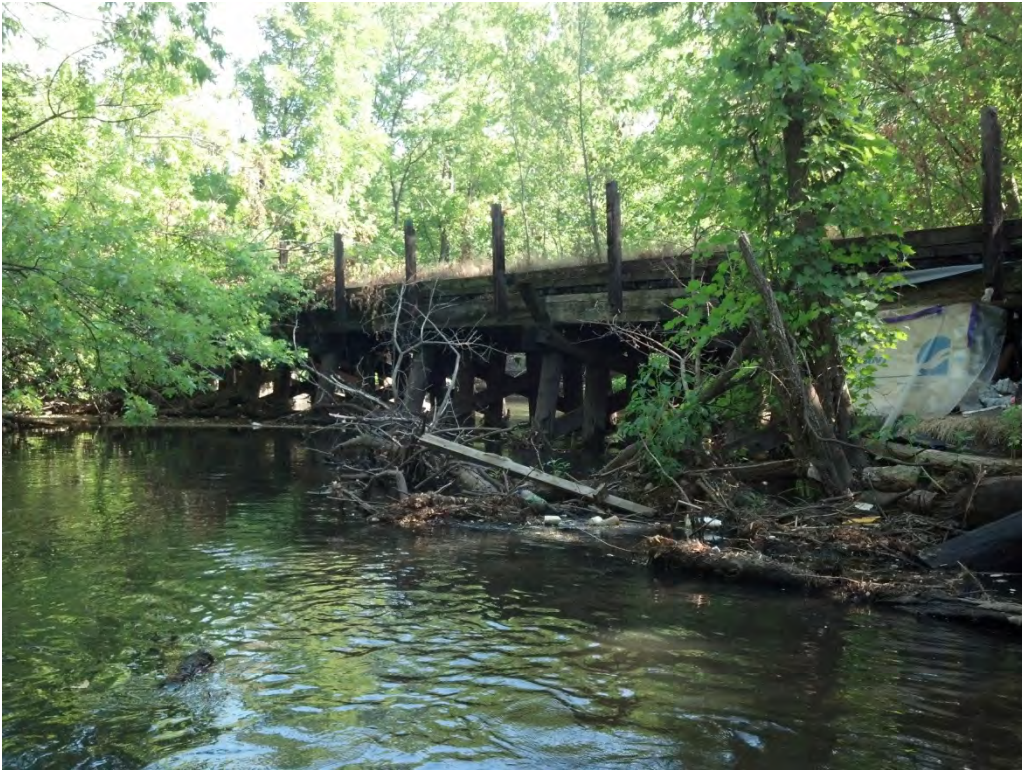
- The surface of the structure is covered with heavy vegetation.
- There is a large amount of squatter debris under the east span of the structure.
- Timber piles have various stages of section loss. The second pile from the south on the east pier has failed from progressed loss, as well as several others.
- Timber beams and pile caps have scattered splitting.
- Railings for the structure have failed.
- Moderate to severe bank erosion was noted around the structure.

View of the structure from the south channel

- Sheet pile cofferdams should be located a minimum of 6 feet from the footprint of the structure to protect battered piling, which extends beyond the footprint. Sand bag cofferdams could be placed closer to the structure.

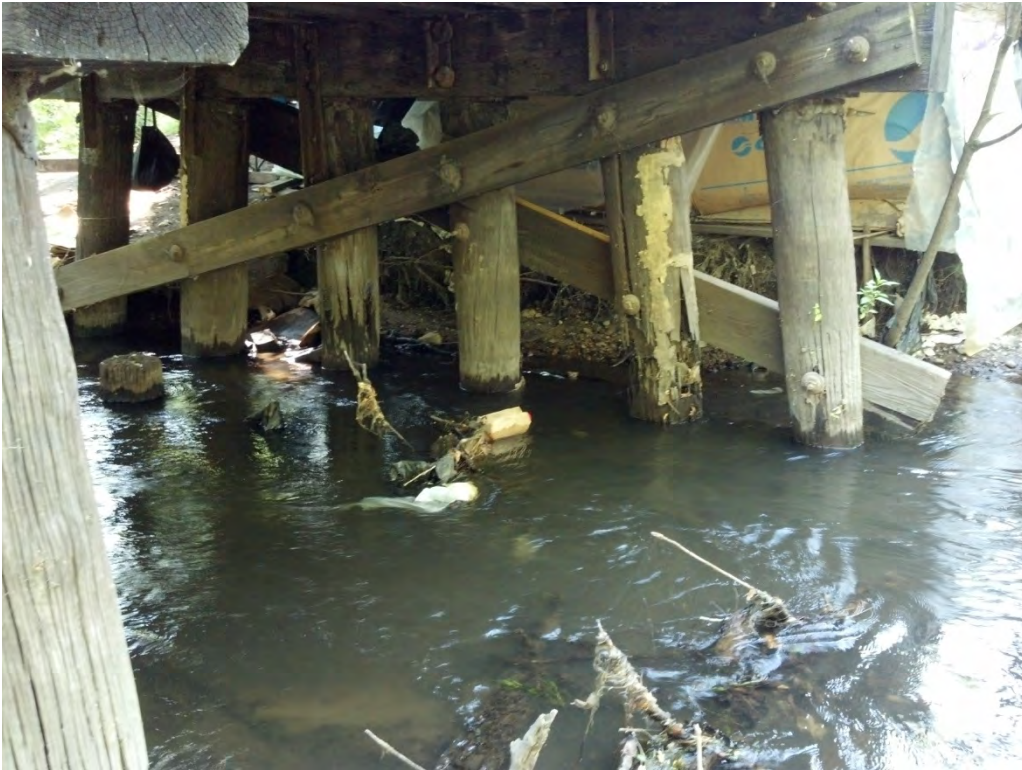
Severe section loss on timber piles of east pier

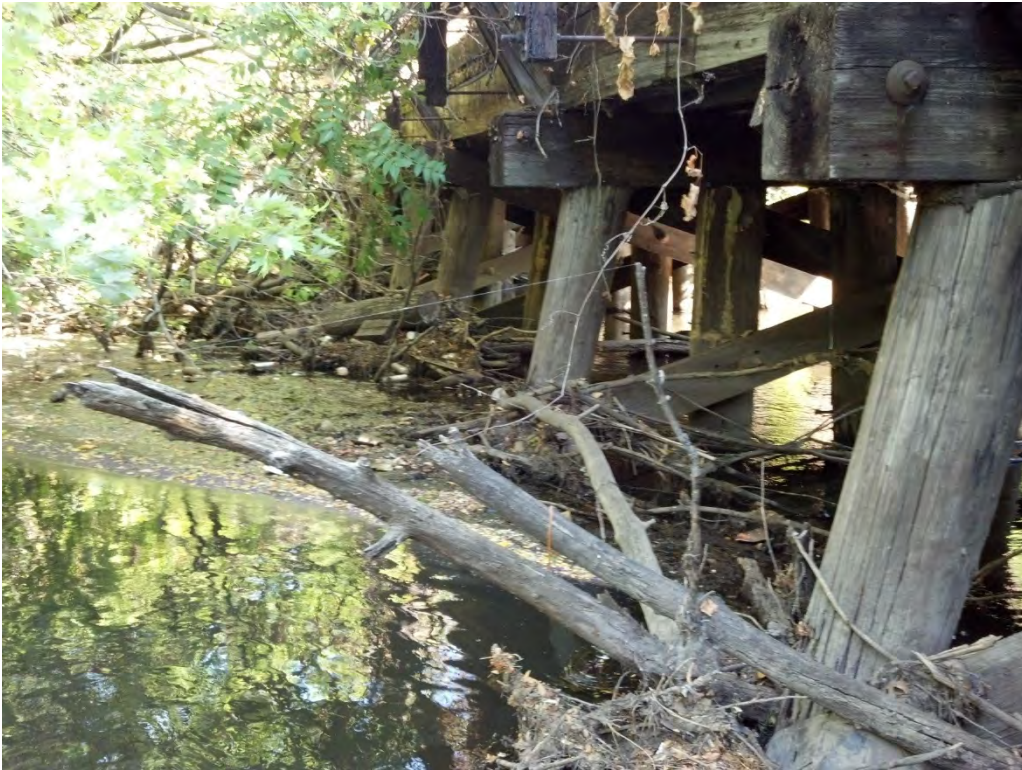
Woody channel debris on upstream end of structure

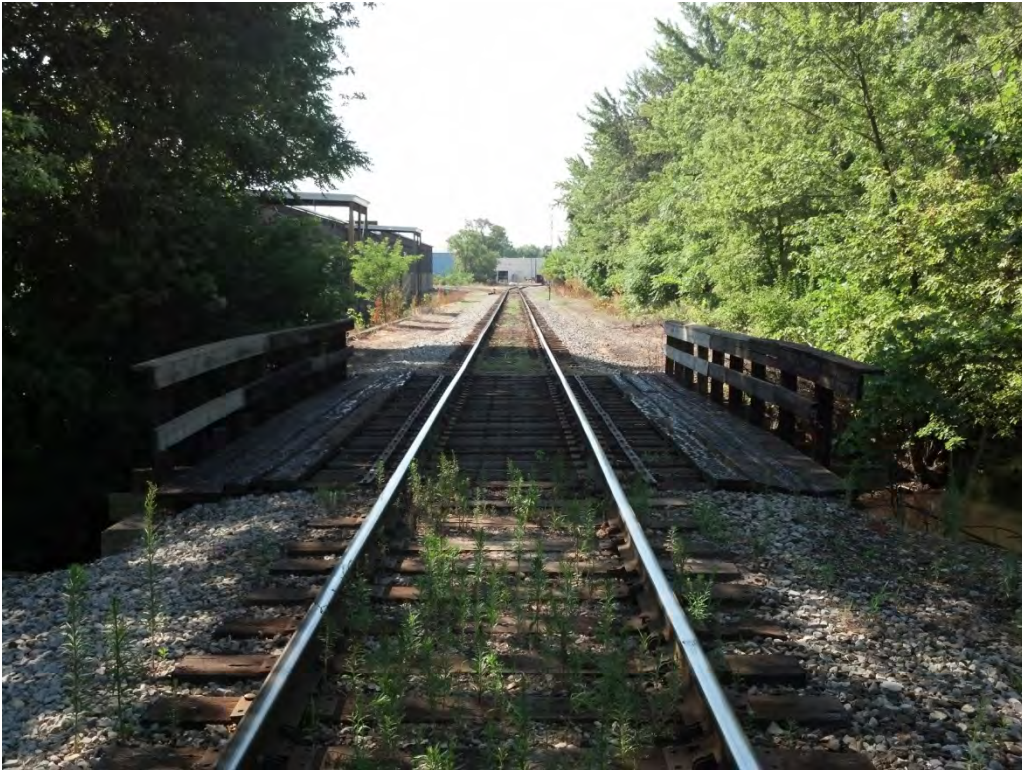
- Concrete abutments appear to be in fair to good condition.
- Moderate to severe bank erosion was noted around the structure.
- Steel girders have minor to moderate corrosion and scale. The steel bearings have moderate surface corrosion.
- The channel is lined with ballast under the structure, which has created a shallow rapid section.
- There is a large tree caught in the channel under the structure.
- The timber ties have moderate creosote bleeding.

View of structure from approach track

- Sheet pile cofferdams should be located a minimum of 6 feet from the footprint of the structure to protect battered piling, which extends beyond the footprint. Sand bag cofferdams could be placed closer to the structure.

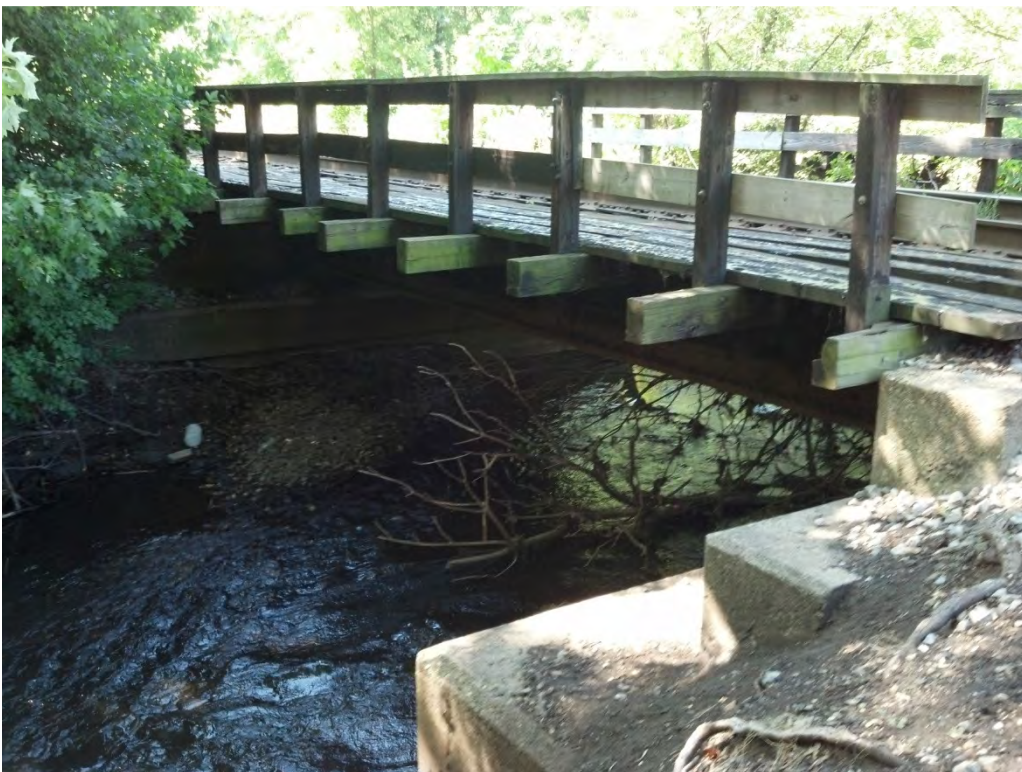
Elevation view of structure

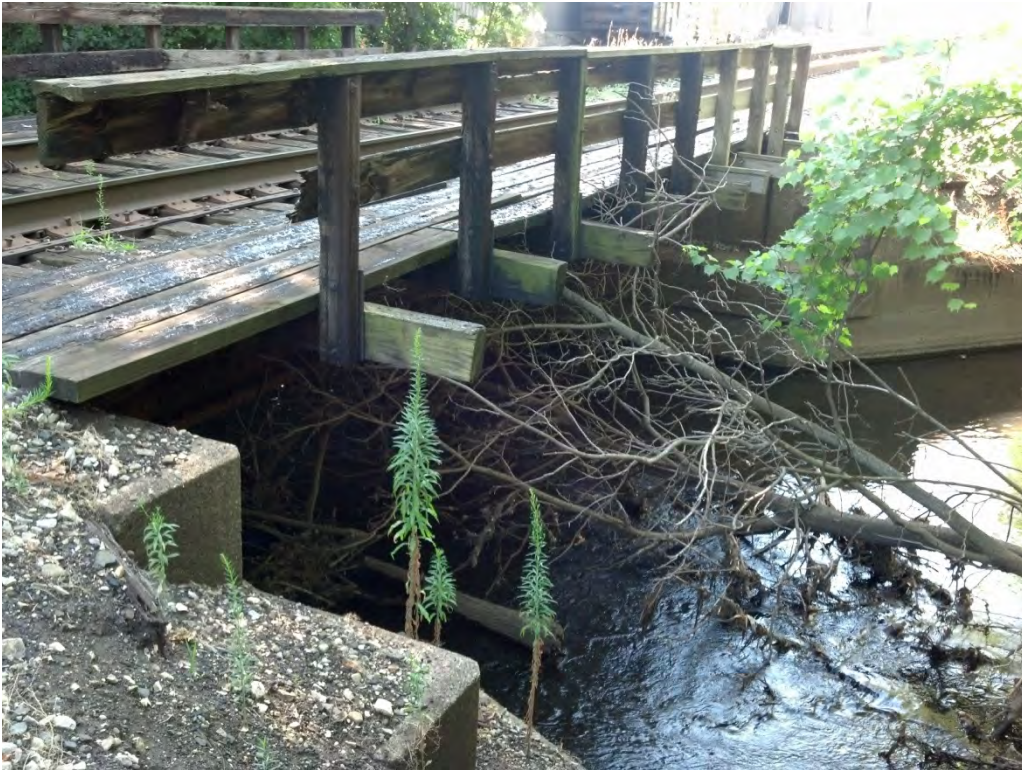
Large tree in channel at structure

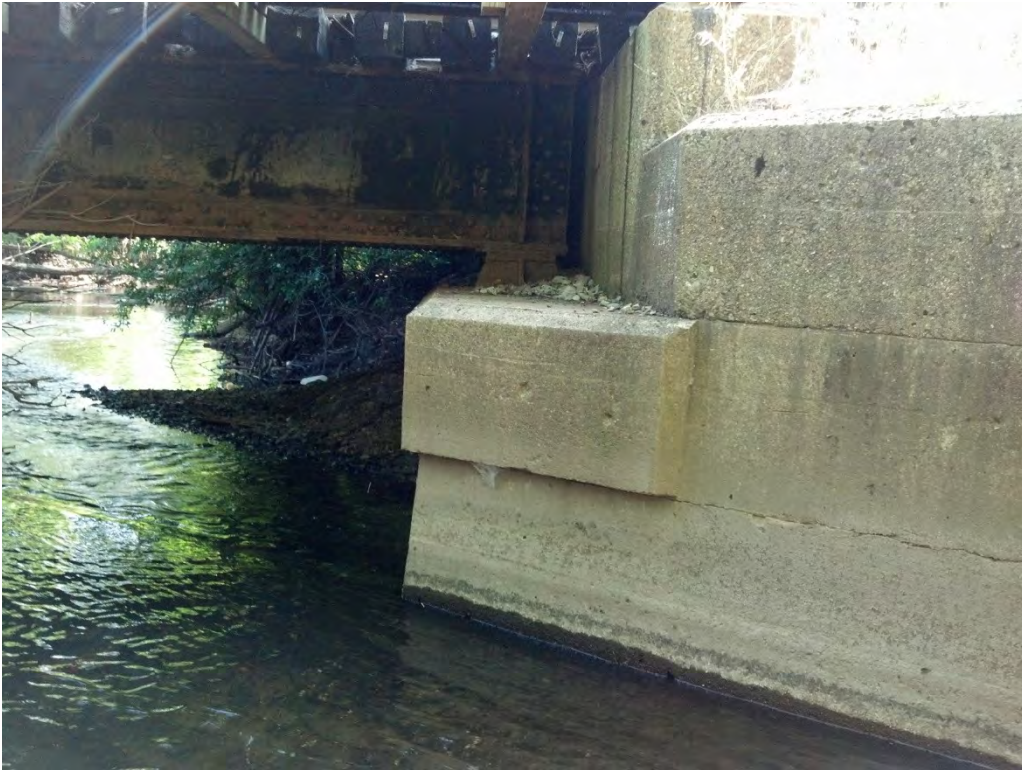
View of bearing area with debris on bridge seat

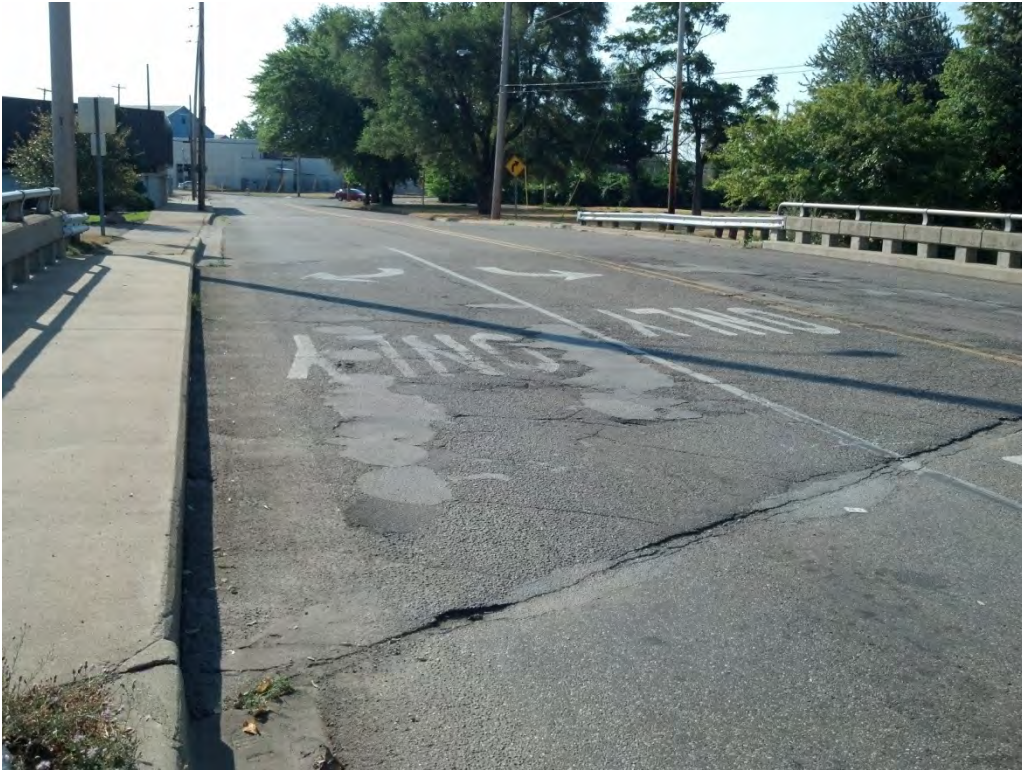
- The asphalt wearing surface is severely cracked and spalled with cold patch. Asphalt approach pavement have scattered cracking.
- The concrete sidewalk (on the north side) has moderate cracking. Approach sidewalks have moderate settlement at the structure. There is severe cracking and spalling in the northeast with exposed steel.

View of structure from the approach area

- We understand that sediment removal is not planned for area SA3-B. If plans change, caution should be used when working around the Pitcher Street Bridge, as it is supported on a shallow foundation system. Sediment excavation should not extend any lower than the bottom of footing elevation, as removal of overburden pressure can reduce the bearing capacity of adjacent soils.
- If a cofferdam is required for dewatering, sheet pile should be installed with a minimum 10' clearance to the bridge. Connections to the gabion baskets at the ends of the cofferdam should be sand bags to avoid damaging the baskets.

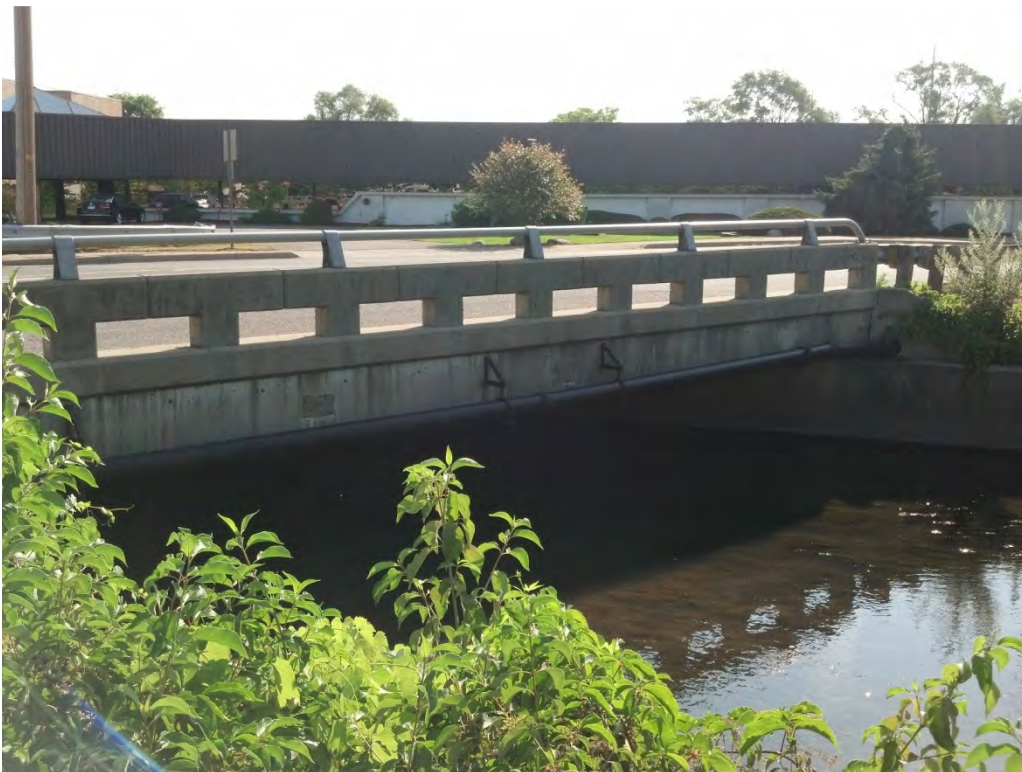
Elevation view of structure

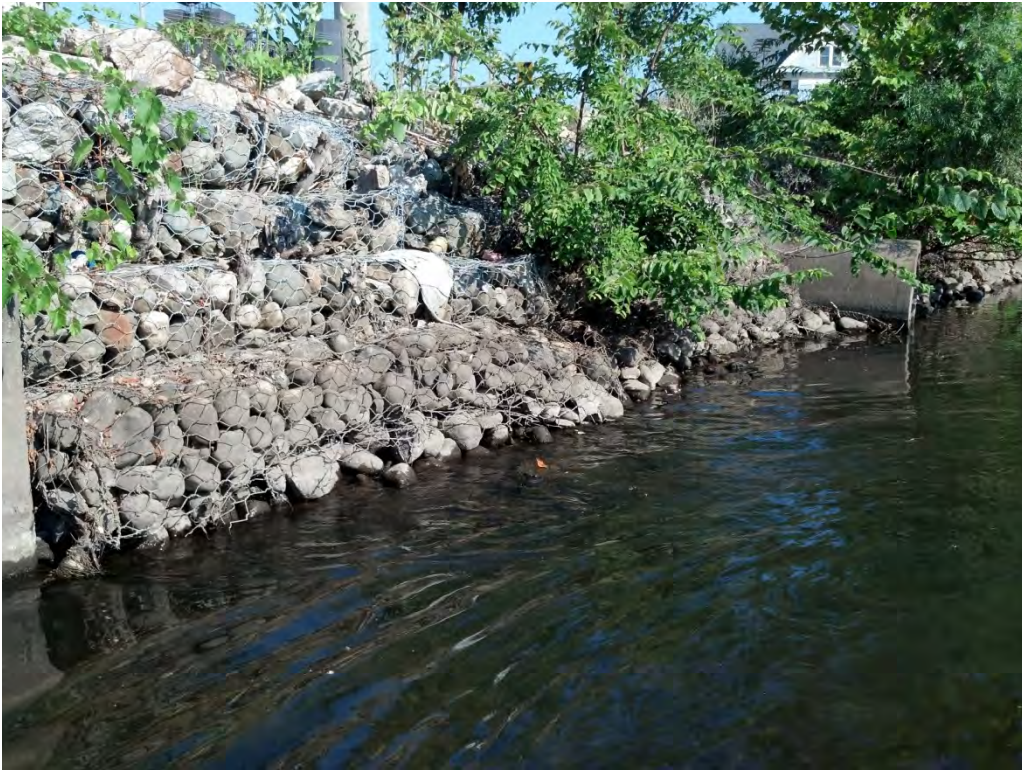
Gabion baskets in northwest with brush growth and displaced stones at waterline

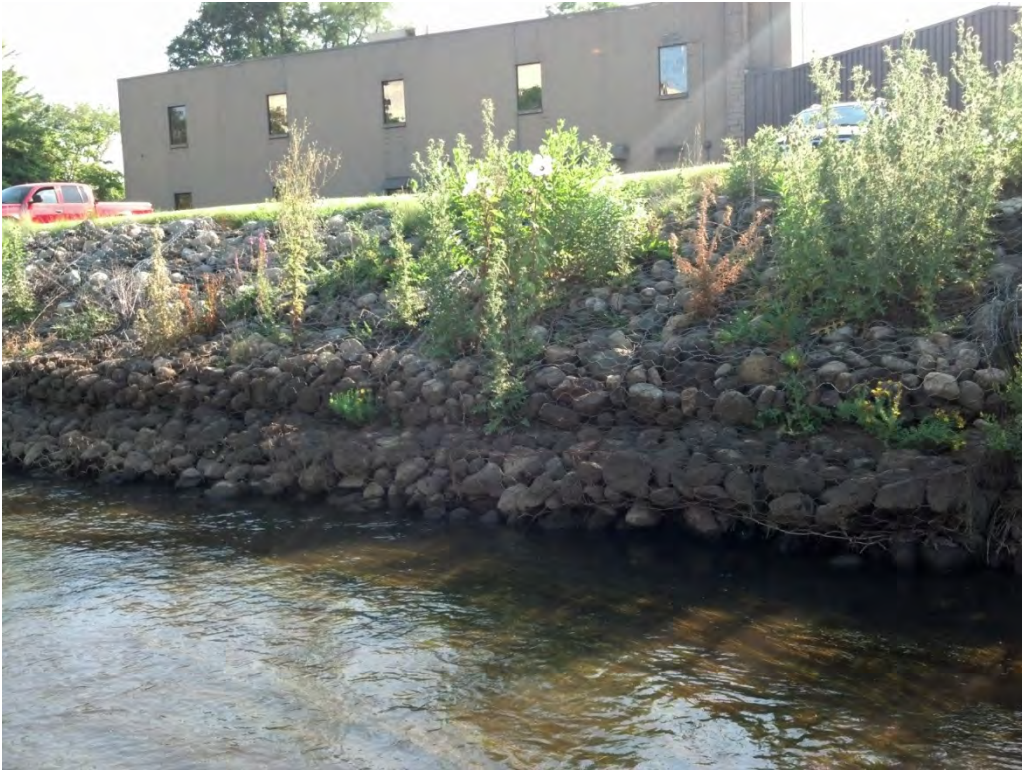
Gabion baskets in northeast with brush growth and displaced stones at waterline

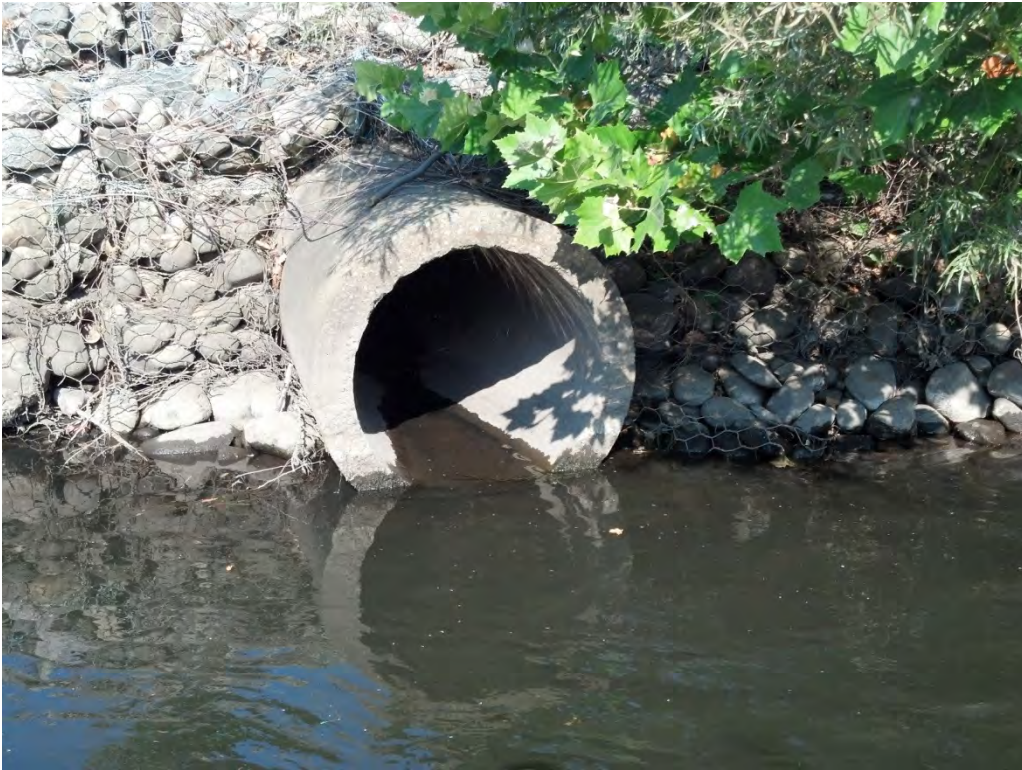
- Approximately 3' of the pipe is exposed beyond the face of the gabion baskets.
- There is a plunge pool approximately 2' deep around the outlet.
- The concrete pipe is in fair to good condition.

Outlet viewed from the channel

- If a cofferdam is required for dewatering, it should be installed with a minimum 2' clearance to the outlet to avoid adversely impacting it. It will be difficult to install a sheet pile cofferdam against the gabion baskets without damaging them. Therefore sand bags are recommended either against the baskets or for the entire cofferdam.

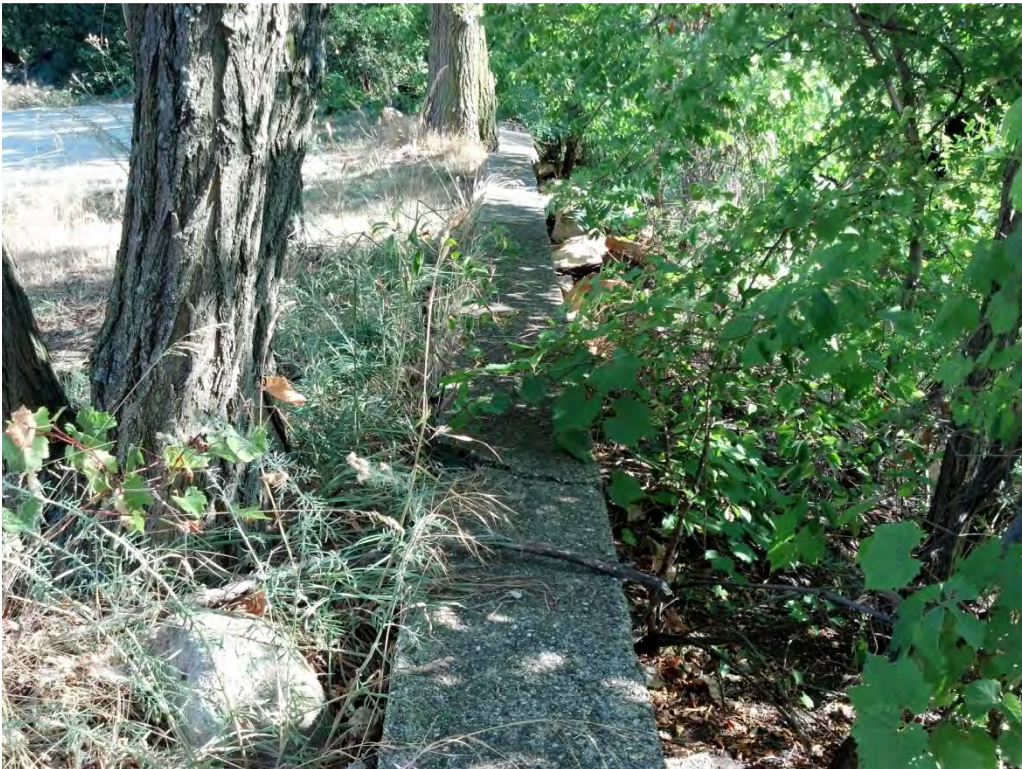
- The concrete retaining wall is in poor condition, leaning in several locations. There are several severe to critical vertical cracks in the wall. Growth of a large tree behind the wall has caused ~2" offset at one of the cracks.
- The parking lot is newer concrete paving.

View of the retaining wall from the south

- The wall and lot are far enough removed from the channel to avoid impact, however they should be protected from equipment damage during the work.

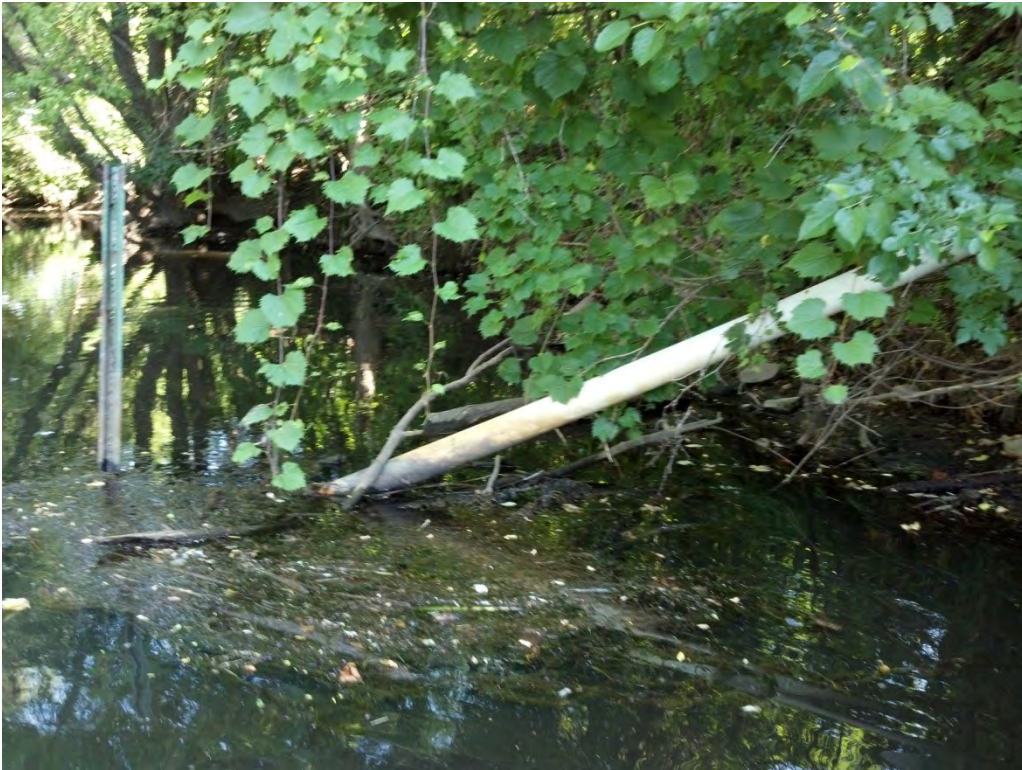
- There is moderate corrosion on the steel post in the channel.
- The PVC sampling tube is not connected to the unit at the top of the bank.

View of PVC sampling tube from south channel

- Coordinate with the City to remove and replace the structure if required for sediment removal.
- Identify the structure to operators and drivers with construction fencing or similar during the work.

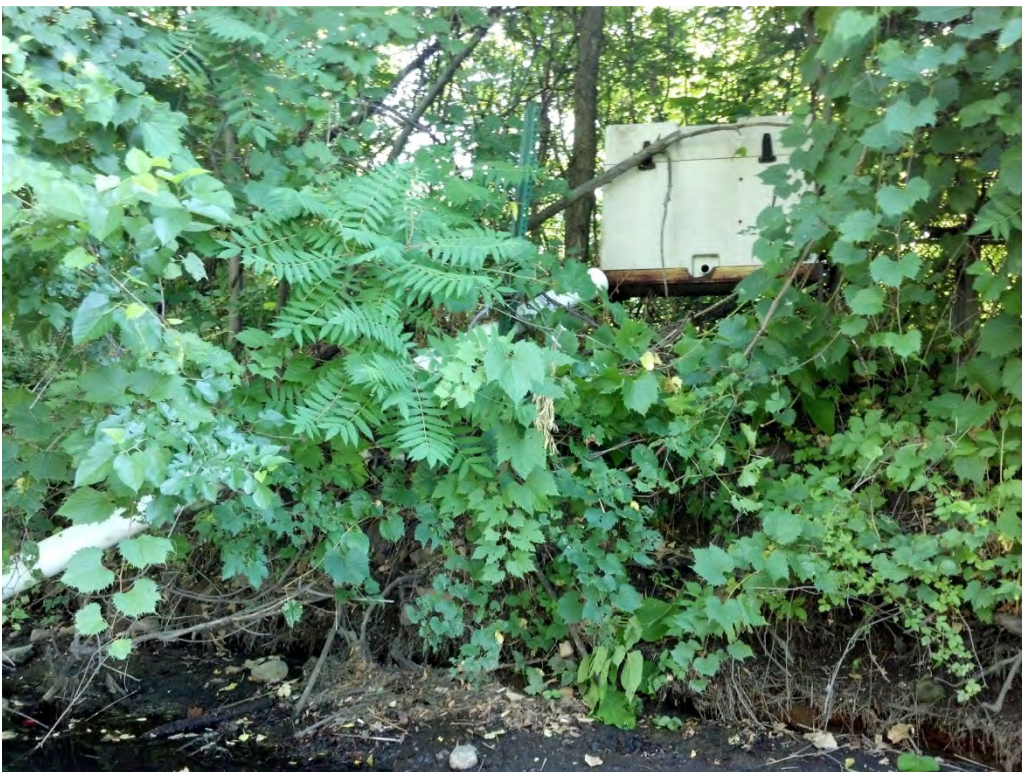
View of structure from channel

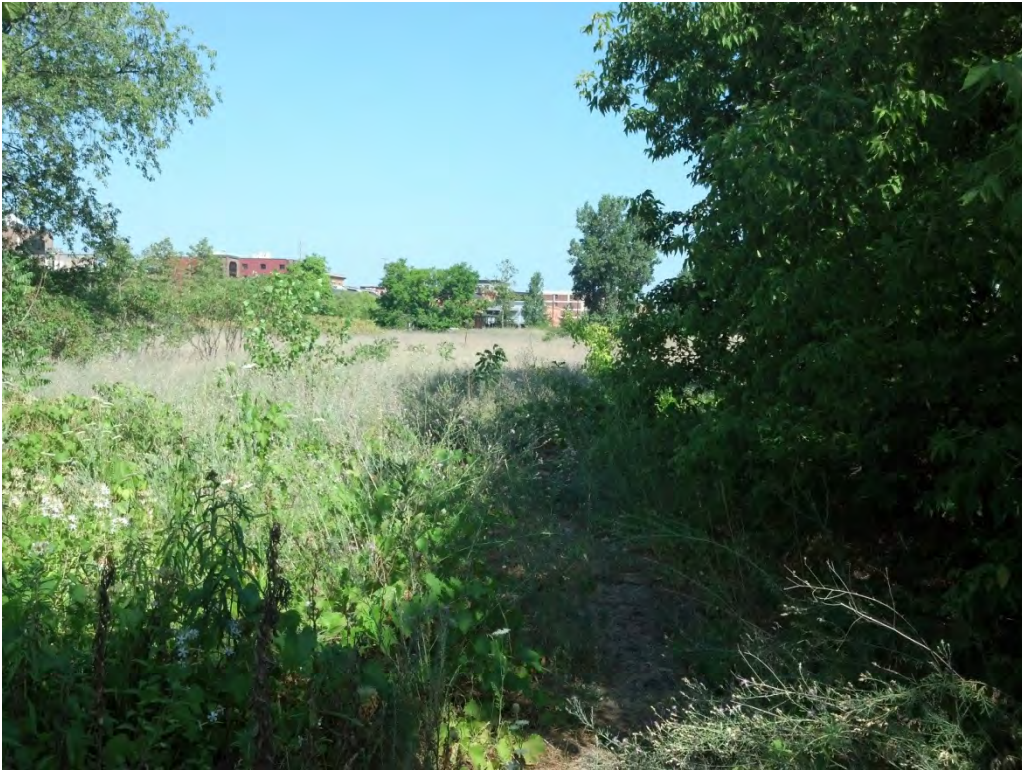
- The field is weed-covered with several paths worn between East Michigan Avenue and area SA3-A. The area along the parking lot in the northwest and along East Michigan Avenue are mowed.

View of area from SA3-A

- The field should be restored as directed by the property owner.

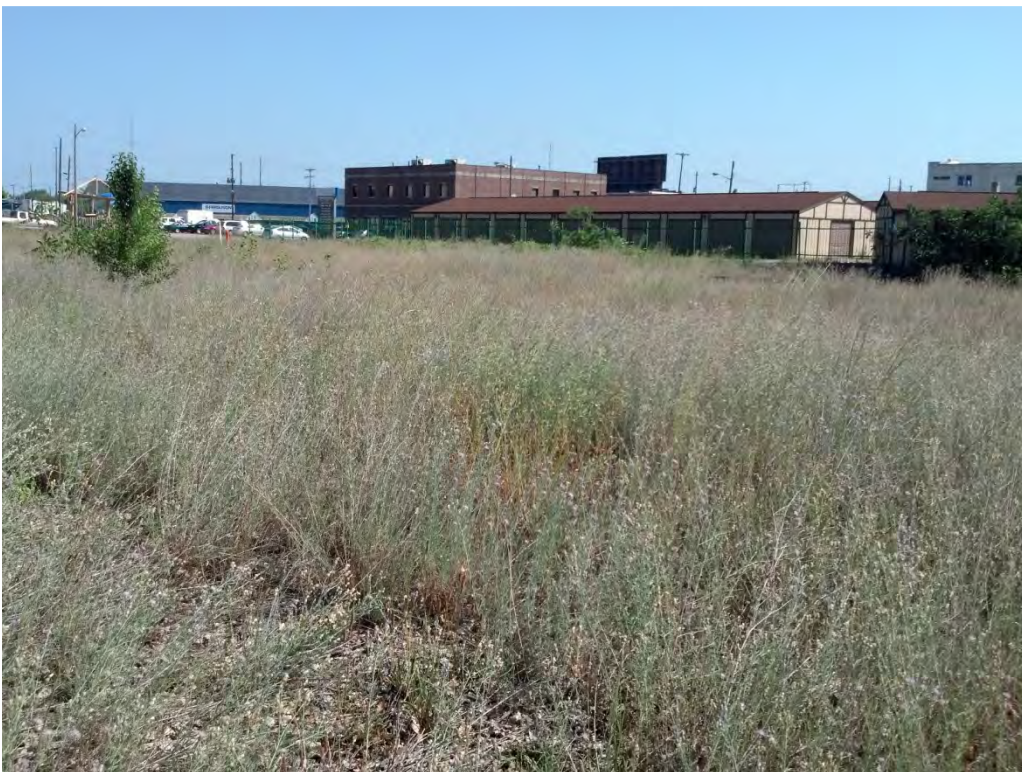
View of area looking northeast

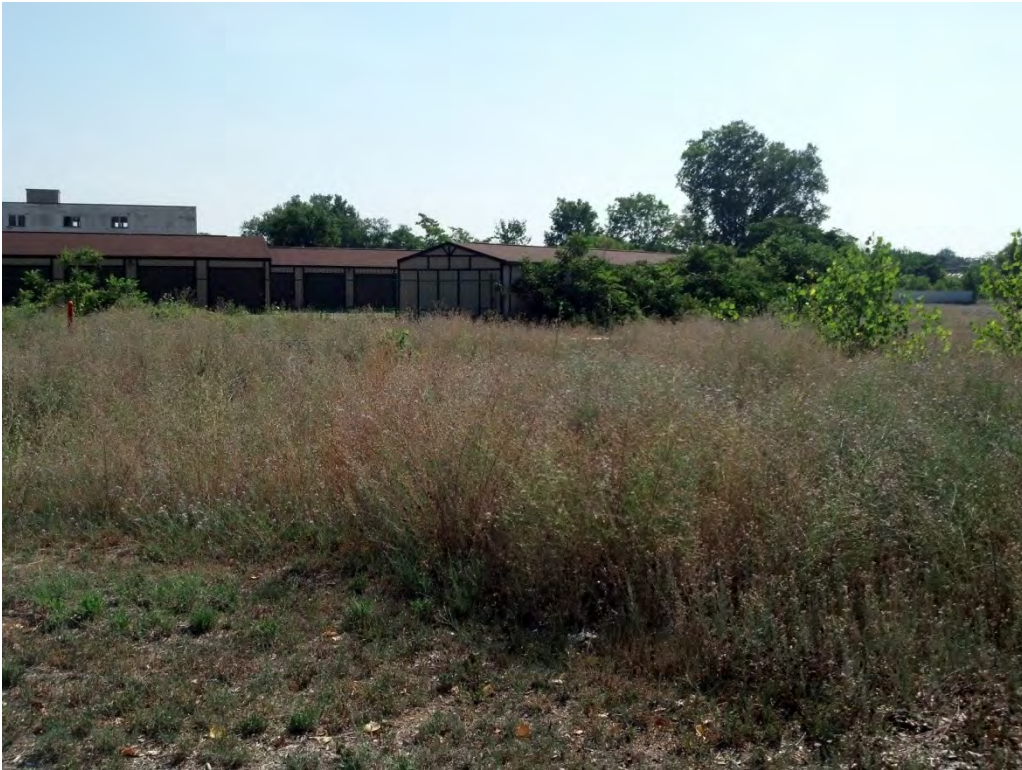
View of area looking east

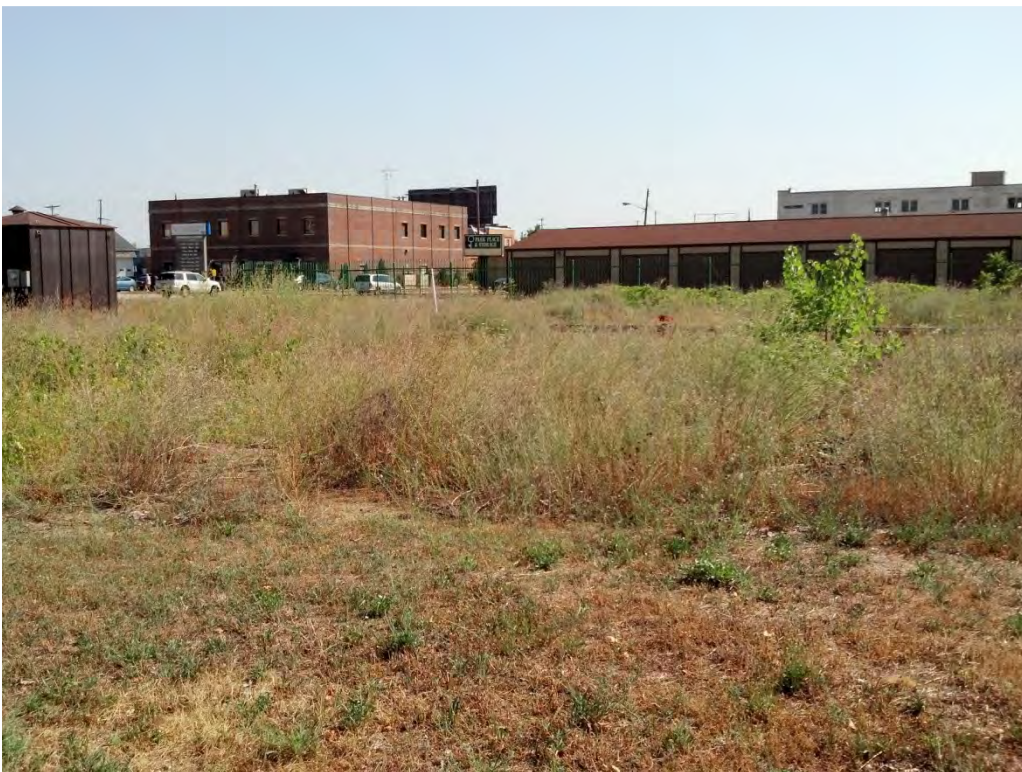
View of area looking east

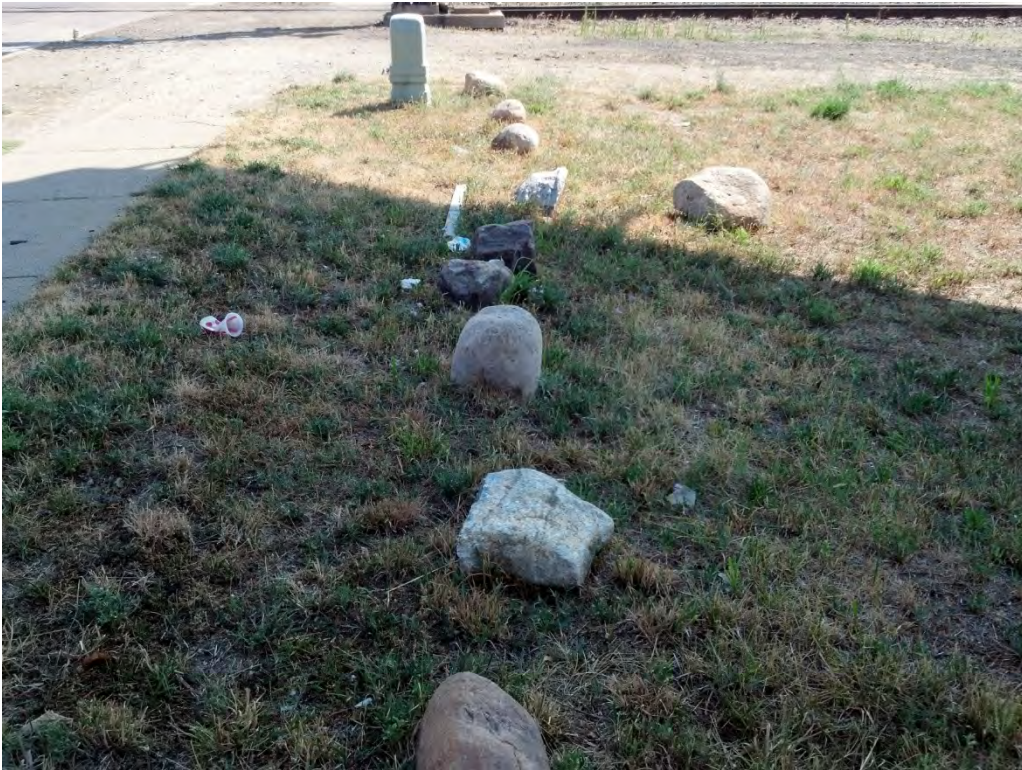
Landscape rocks at north end of field

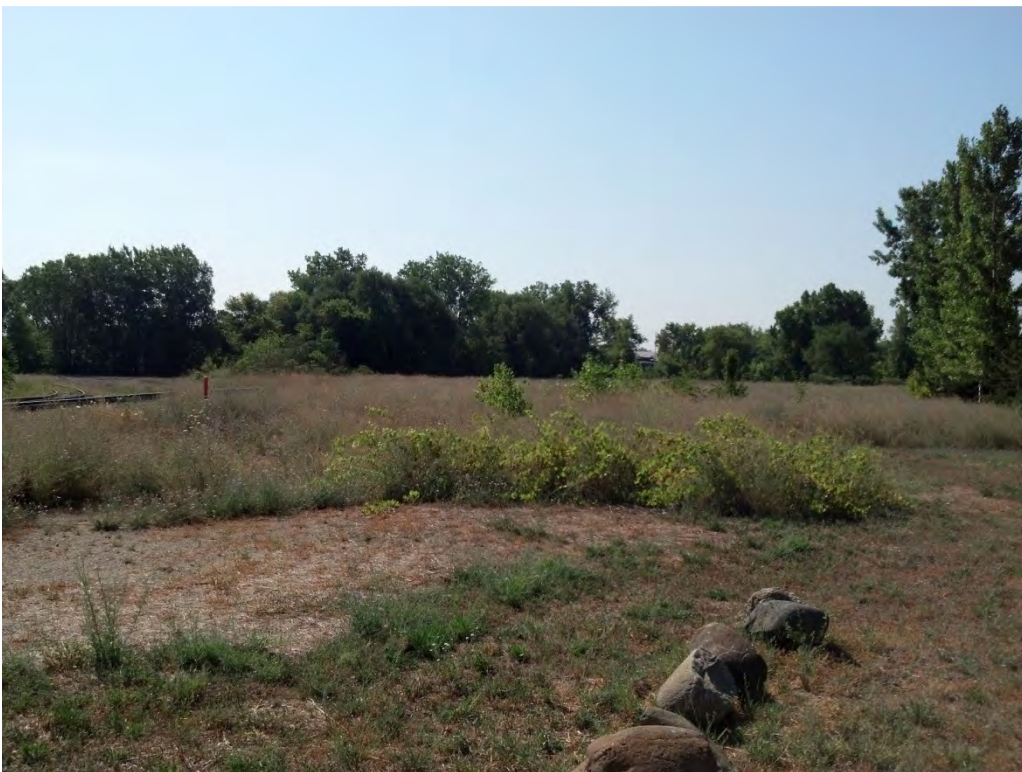
View of area looking south
